SEA-Mate® Blending-on-Board

CASE STUDY: Grete Maersk

VESSEL DATA

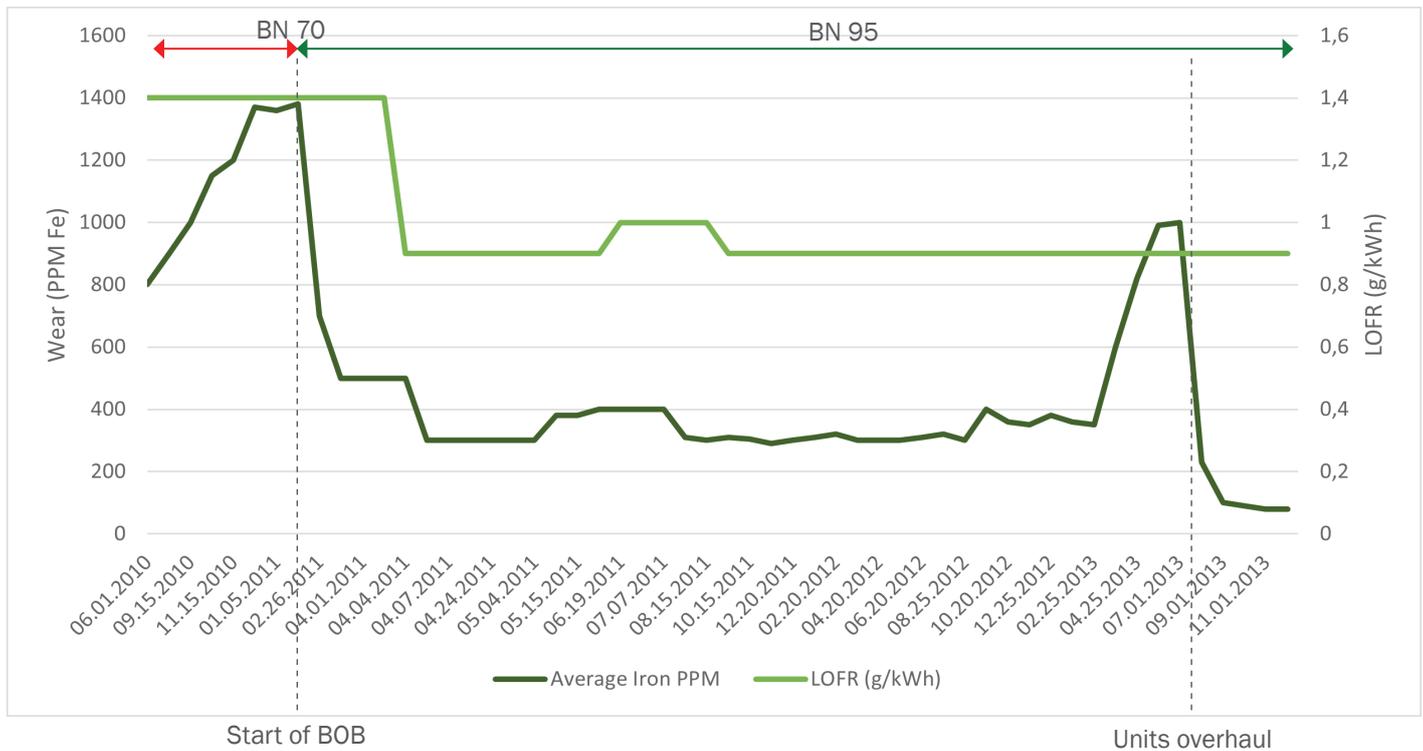
The graph illustrates that while the engine was operating with a high sulphur fuel (>3.4 S%), cold corrosion was taking place, inducing a high wear rate of the liners and piston rings. With BOB, an optimization of the cylinder lubrication feed rate was made possible by the adjustment of the BN from 70 to 100, performed in a safe way as the actual condition and wear behavior of the engine could be monitored with the SEA-Mate XRF Analyzer. During 2011, the cylinder units were in a recovery mode, and a careful monitoring of the cylinder condition with the SEA-Mate XRF Analyzer confirmed the stabilized wear situation, and the wear rate was further reduced by continuously adjusting the BN and the cylinder oil feed rate to the actual wear behaviour of the engine.

Before the SEA-Mate® BOB system was installed, the cylinder liners experienced severe corrosive wear, leading to excessive engine wear of 0.7 mm/1,000 running hours. Shortly after the BOB system was put into operation, the feed rate was reduced from an average of 1.46 g/kWh at 70BN cylinder oil, to 0.9 g/kWh and a variable BN operation ranging from 40 to 100 BN was applied. Immediately the cylinder conditions started to stabilize as the cylinder oil BN was continuously adjusted to meet the operation conditions and fuel sulfur used, the piston ring and cylinder liner wear rates were significantly reduced as per the graph, thus allowing an extension of the parts TBO (Time-between-Overhaul)

The installation of a Blending-on-Board (BOB) lubrication system in March 2011 drastically changed the situation by decreasing the wear rates observed (see Graph). Likewise, the condition of the cylinder unit and its piston rings started to improve.

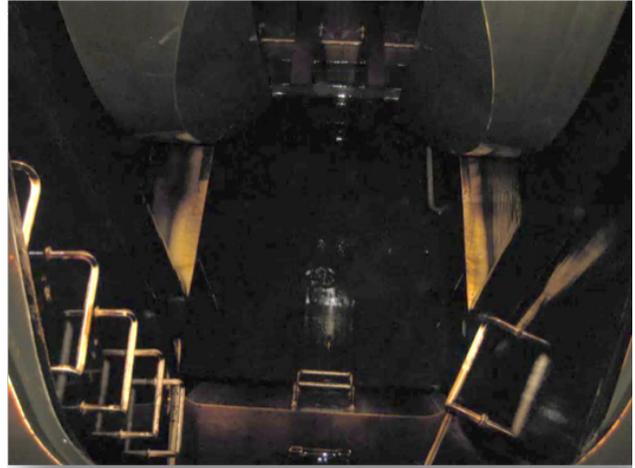
Figure 1 - Crank case before BOB operation

In March 2011 the crankcase condition were very dirty as seen on figure 1. After introducing the BOB unit to the vessel and six months of continuously refreshment of ME system oil was clear. The Engine crankcase was showing a significantly cleaner appearance as pr. figure 2. The advantages of having a clean crank case and cleaner, fresher system oil are numerous and not only

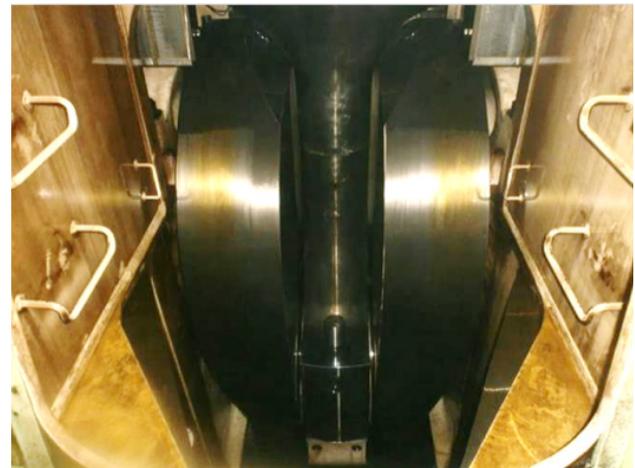
Figure 2 - Crank case after six months of BOB operation

- System oil properties, like detergency, dispersancy and anti-oxidation (necessary for optimum engine performance), are restored.
- Critical components, such as bearings, fuel pumps, and the piston cooling system, will perform optimally.
- It improves viscosity control, reduces friction losses in the engine, and ultimately delivers a substantial fuel saving of up to 0.5%.
